DEPARTMENT OF TRANSPORTATION**DIVISION OF ENGINEERING SERVICES**

Contract #: 04-0120F4Cty: SF/ALA Rte: 80 PM: 13.2/13.9File #: 69.28**WELDING INSPECTION REPORT****Resident Engineer:**Pursell, Gary**Address:** 333 Burma Road**City:** Oakland, CA 94607**Report No:** WIR-004823**Date Inspected:** 28-Nov-2008**Project Name:** SAS Superstructure**OSM Arrival Time:** 630**Prime Contractor:** American Bridge/Fluor Enterprises, a JV**OSM Departure Time:** 1530**Contractor:** Zhenhua Port Machinery Company, Ltd (ZPMC), Changxing Island **Location:** Shanghai, China**CWI Name:** Sun Wei**CWI Present:** Yes No**Inspected CWI report:** Yes No N/A**Rod Oven in Use:** Yes No N/A**Electrode to specification:** Yes No N/A**Weld Procedures Followed:** Yes No N/A**Qualified Welders:** Yes No N/A**Verified Joint Fit-up:** Yes No N/A**Approved Drawings:** Yes No N/A**Approved WPS:** Yes No N/A**Delayed / Cancelled:** Yes No N/A**Bridge No:** 34-0006**Component:** OBG**Summary of Items Observed:**

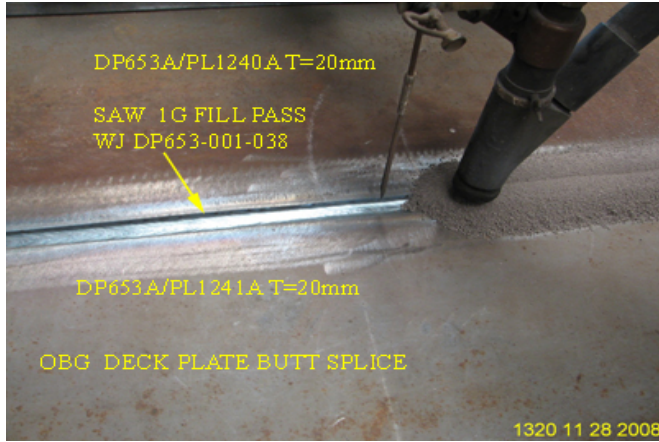
The QA Inspector randomly observed ZPMC welder Wu Zhi Bin ID 049804, utilizing the Submerged Arc Welding (SAW) Process in 1G Position 1 with ZPMC Weld Procedure Specification (WPS) WPS-B-T-3221-B-U3c-S-1, to weld a butt splice between Deck Plate DP653-001 Sections DP653A/PL1240A and DP653A/PL1241A at Weld Joint (WJ) DP653-001-038. The QA Inspector randomly observed ZPMC QC monitoring weld parameters. Weld parameters appeared to comply with contract requirements. The attached

photograph provides additional detail.

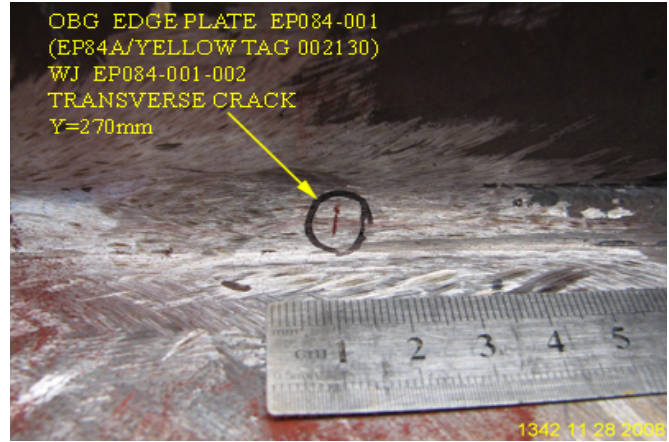
The QA Inspector randomly observed ZPMC NDT Technician Cai Xin Xin, utilizing the MT Method to attempt to perform a final MT examination on the cover pass of the fillet welds on Edge Plate EP84A Yellow Tag 002130 (EP084-001) Location 8CW-F9 WJ's 001 through 004. Mr. Cai and the QA Inspector observed a transverse crack in WJ 004 at Y=270 mm. Mr. Cai rejected the MT examination of EP84A. The attached photograph provides additional detail.
